Draft Final Report • National Institute of Standards and Technology (NIST)

of the May 22, 2011,
Tornado in
Joplin, Missouri

NIST NCSTAR 3 (Draft)

November 2013

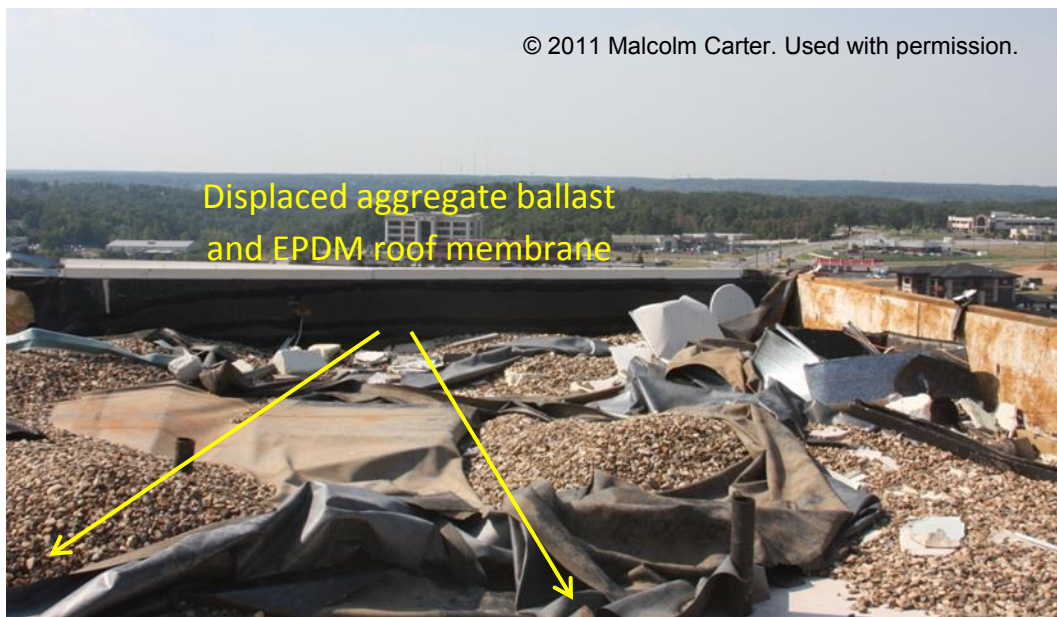
- Loss of aggregate ballast from the roof and subsequent peeling–off of the roof covering system (EPDM roofing membrane and rigid insulation, similar to the West Tower; see Figures 3–18 and 3–19). As noted for the West Tower, the nine–story East Tower, with its mean roof height of 109.4 ft (just under the IBC limit of 110 ft), was considered code–compliant for use of roof aggregate ballast. It is not known if aggregate was used as roof ballast for the taller 10–story elevator tower (126.9 ft mean roof height). Regardless of the code height limit, there was evidence that the roof aggregate did contribute to the damage sustained by the envelopes of adjacent buildings.
- There was significant damage to the interior of the East Tower and the connecting elevator tower, including damage to the elevator shaft wall.

Figure 3–18. Damage to roof covering system of East Tower (peeling–off of EPDM roof membrane and rigid insulation, loss/displacement of roof aggregate ballast).

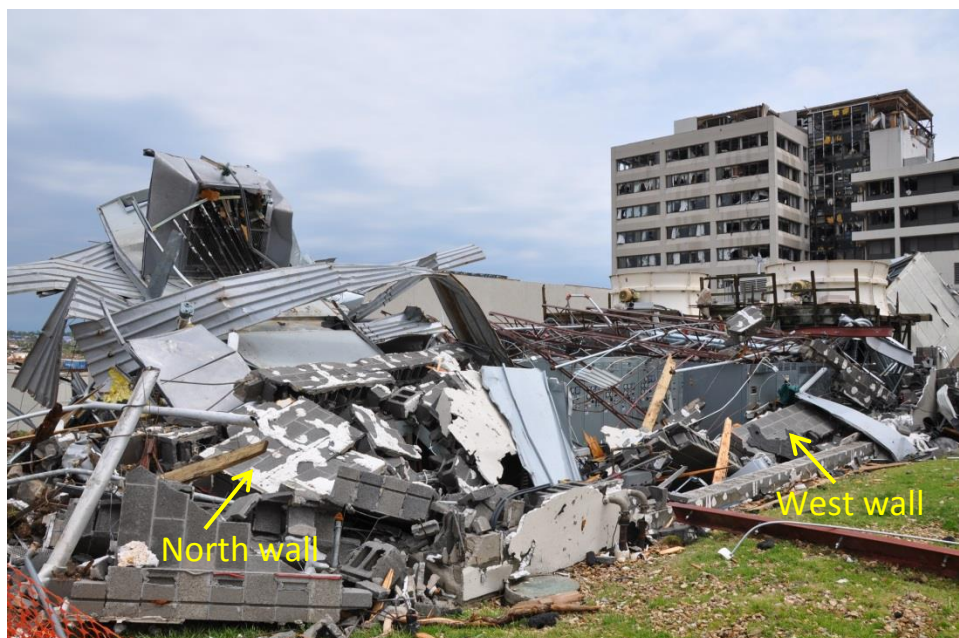
Figure 3–20. View from northwest of Emergency Generator Building. Note northward and eastward direction of wall failure, consistent with the direction of maximum wind (westerly) shown on Figure 3–7.

- The building sustained total collapse, with damage typical of structural damage associated with BTS buildings in extreme wind hazards. The metal roof system (metal deck panels and steel bar joists), which provided lateral bracing for the exterior CMU walls, failed completely, likely due to wind uplift pressure. Observations made following the tornado found that roof deck panels had peeled off from the supporting steel roof trusses (tension failure of the puddle welds connecting the roof deck to the bar joists due to wind uplift) and the ends of the roof trusses that were anchored into the bond beams on top of the exterior walls had disconnected from the walls. All four exterior CMU walls (except for small portions of the south and east walls) collapsed. Figures 3–20 and 3–21 show views from the northwest and northeast corners of this building, respectively. Note that both the west and east walls of the building collapsed eastward, which was the translational direction of the tornado and also consistent with the wind direction estimated by wind field model (see Chapter 2). Also note that the door and louver on the east wall and the louver on the north wall were pushed outward, indicating high internal wind pressure acting on the walls of this building. Figure 3–22 shows the reinforcement of the bond beam and the disconnected anchor that formerly connected the end of the steel roof truss to the wall.

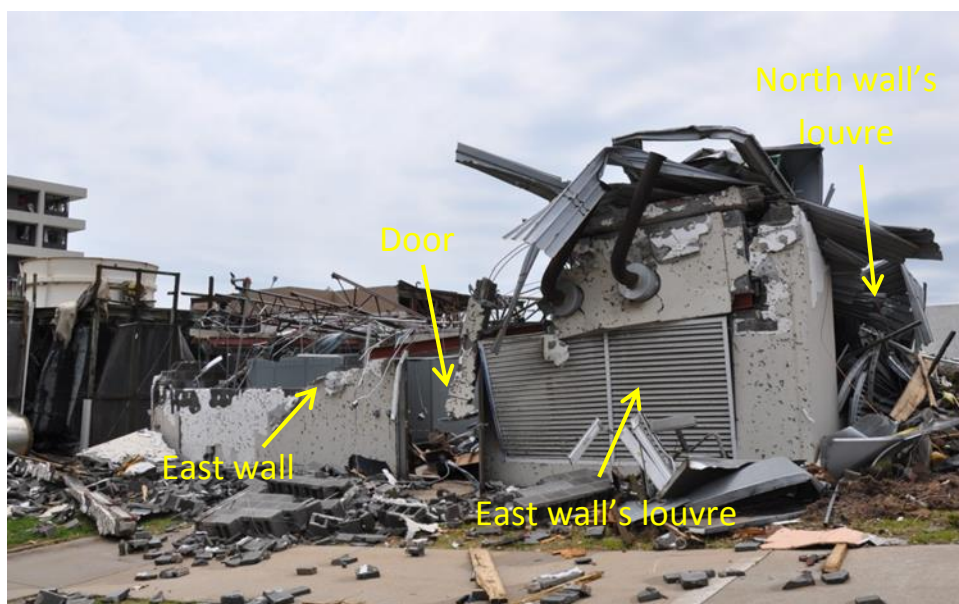
Figure 3–21. East side of Emergency Generator Building. Note eastward direction of failure on east wall (CMU wall falling outward, door opened, louver pushed outward). Also note louver on north wall pushed outward, consistent with direction of maximum westerly wind and indicative of high internal pressure.

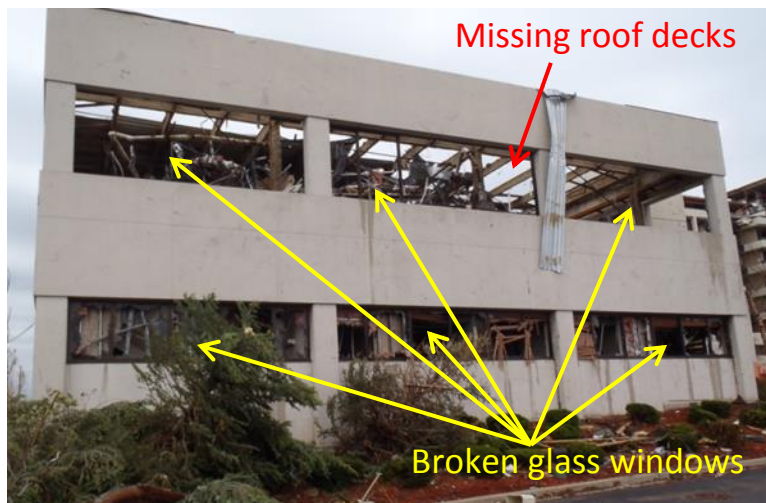
Figure 3–24. South elevation of Oncology Clinic Building showing damage to building envelope (broken glass windows, missing window frame, missing roof decks).

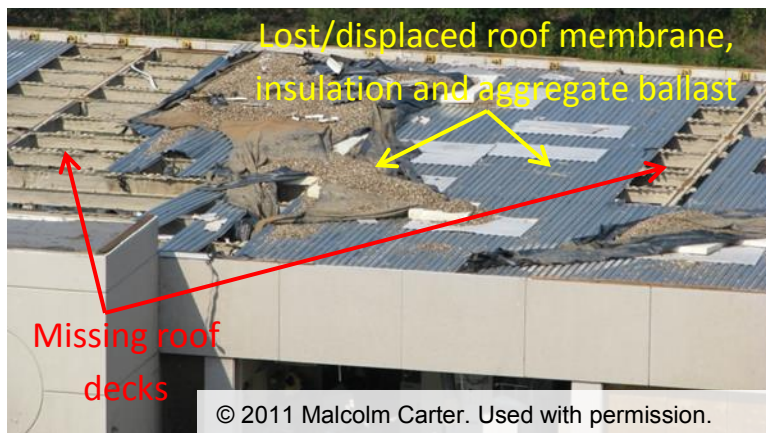
- There was no structural damage to the lateral load system (steel moment frame MWFRS) or the gravity load floor system (composite RC-on-steel deck).
- The building envelope sustained significant damage, including:
 - Breakage of all insulated glass panels and the loss of window systems (glass and aluminum frame), likely caused by both wind pressure and the impact of wind-borne debris based on site inspection, on all wind-exposed sides of the building (see Fig. 3–24).
 - Loss of several panels of steel roof deck, roof aggregate, membrane, rigid insulation, and gypsum board (see Fig. 3–25 and 3–26).

Figure 3–25. Roof of Oncology Clinic Building: missing steel deck panels, gypsum board, rigid insulation, membrane, and aggregate ballast.

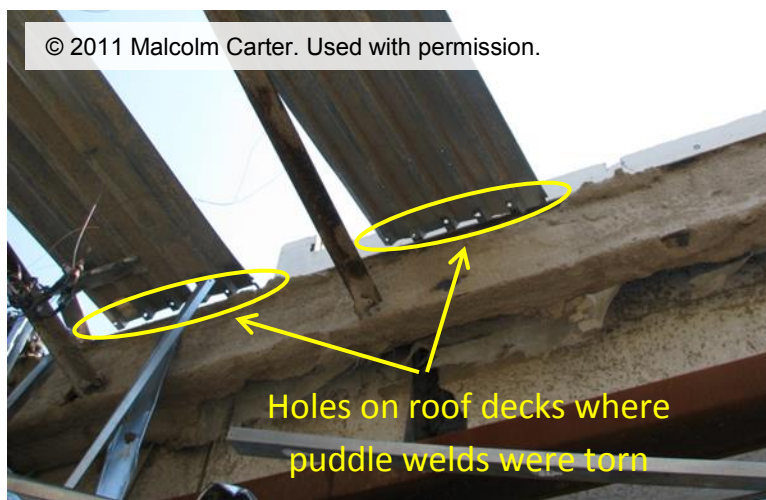
Figure 3–26. Roof of Oncology Clinic Building: failed puddle welds connecting roof deck with supporting roof beam.

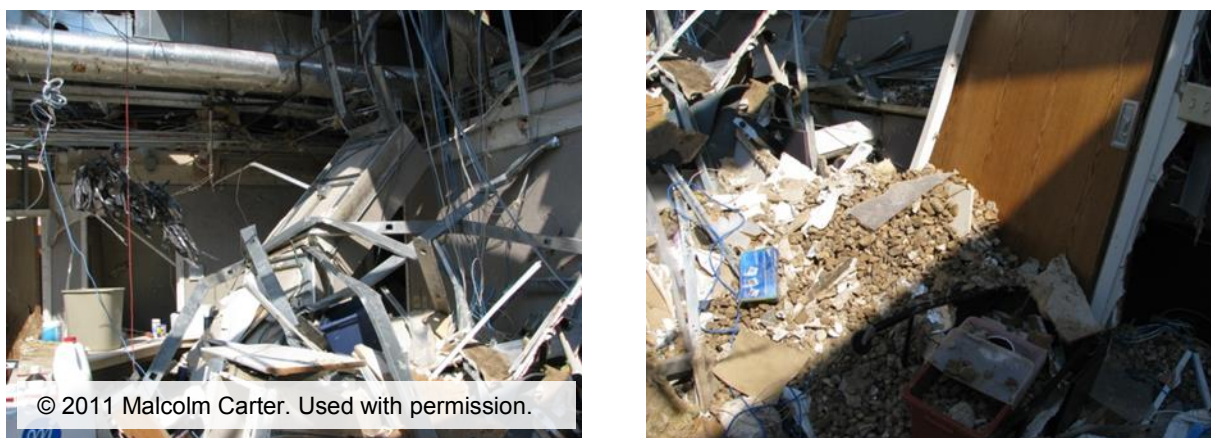
- There was significant damage to the interior of the building, including:
 - Breakage or collapse of interior partitions, metal wall studs, suspended ceiling systems (hanging grid and lay-in ceiling tiles), furniture, fixtures, and equipment (electrical fixtures and wiring, HVAC ductwork, and general building contents) (see Figure 3–27).
 - Infiltration of water and debris (including roof aggregate), and dislodging of building hazardous materials.

Figure 3–27. In Oncology Clinic Building, interior damage to ductwork, electrical wiring, suspended ceiling, interior partition/metal stud wall, furniture. Note the aggregate from roof in the interior.

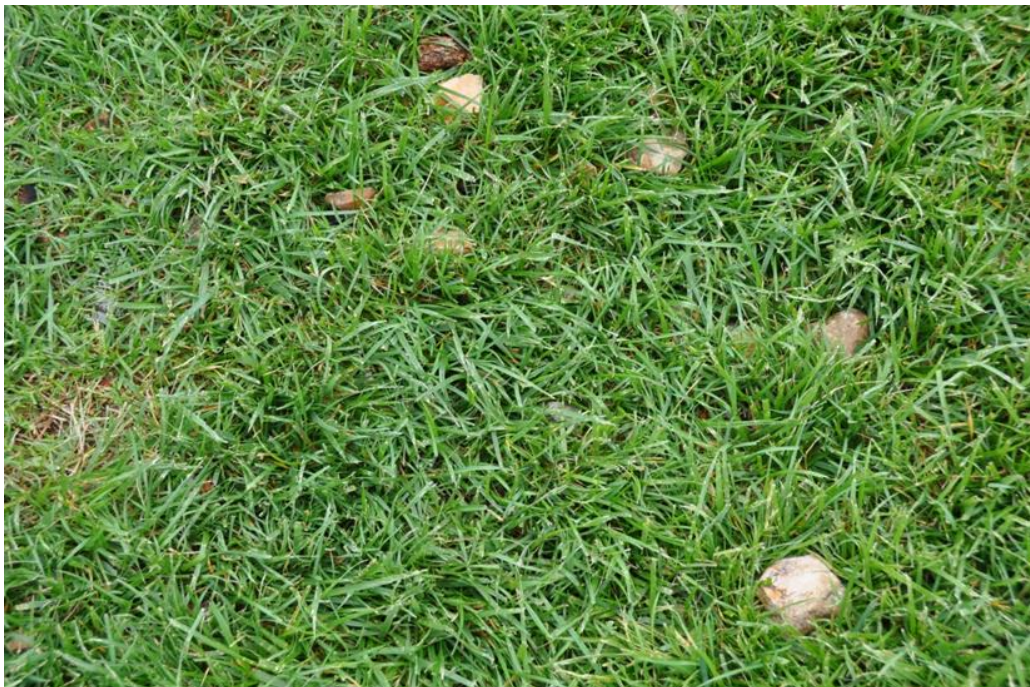
Figure 3–31. Roof aggregate ballast became wind-borne debris (on ground by Medical Office Building 2).

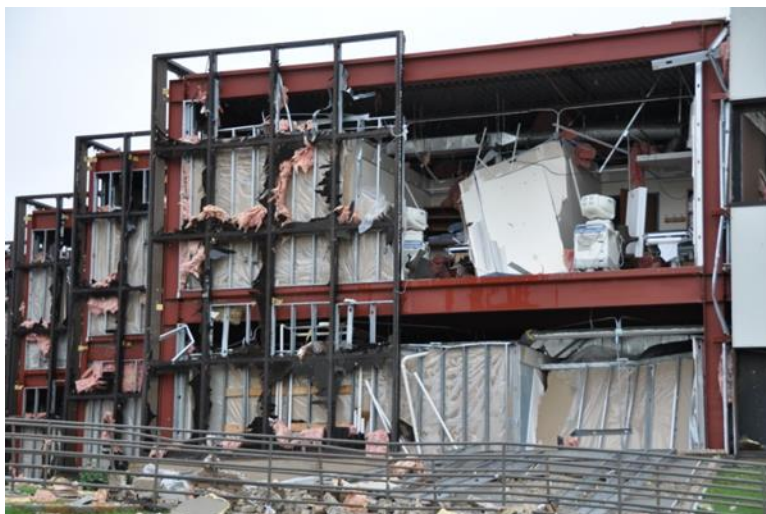
Breakage of curtain walls (broken glass windows and loss of architectural metal panels) and collapse of an entire brick veneer curtain wall and the supporting aluminum stud frame on the south-facing wall of the building (see Fig. 3–32).

Figure 3–32. Collapse of an entire brick veneer curtain wall and the supporting aluminum stud frame on the south-facing wall of Physician's Office Building.

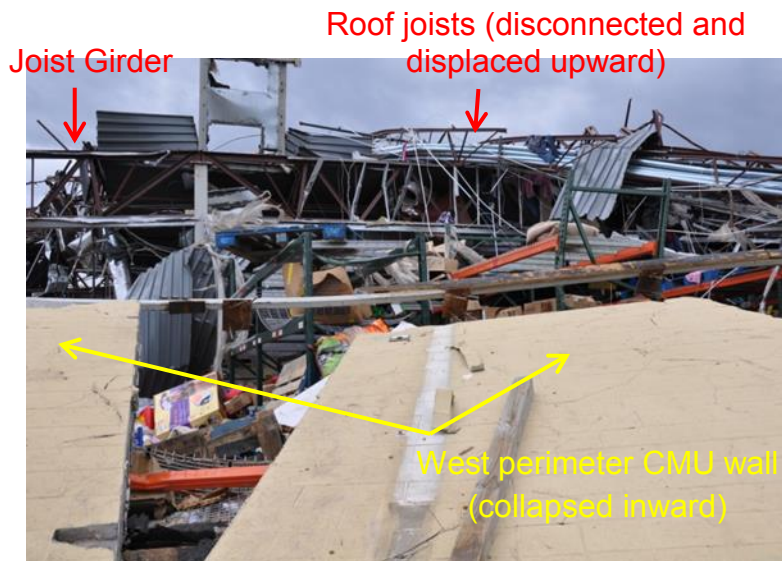
- The MWFRS of the south half of the building (perimeter walls laterally braced by roof system) completely collapsed, with:
 - The entire roof system (roof deck and roof joists) disconnected and either displaced upward or was completely blown away from the supporting joist girders and walls (evidence of wind uplift action, see Fig. 3–37 and 3–38).
 - The west and east walls (where the roof system that was supposed to provide lateral bracing was lost), and portions of the south wall, collapsed inward due to rotation at the base.
- The MWFRS of the north half partially collapsed, with:
 - A portion of the roof system (southeast corner) disconnected and either displaced upward or blown away from the supporting joist girders and walls (see Fig. 3–37 and 3–38).
 - A section of the east wall that was braced by this portion of the roof collapsed inward due to rotation at the base.

Figure 3–37. Roof system (decks and joists) missing. Some roof joists displaced upward (top chords used to be at same elevation as top chords of joist girders, but now sitting above joist girders), showing evidence of wind uplift action as primary cause of failure.

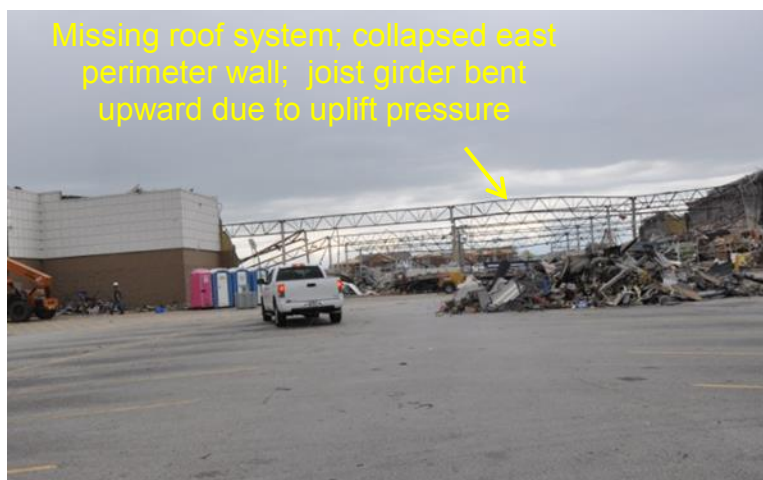
Figure 3–38. Large area of roof system shown missing. Joist girders bent upward due to uplift pressure.

- The gravity system (steel plane frames) was mostly intact, albeit damaged, with:
 - Most joist girders having remained in place and connected to the columns, although many were damaged and bent upward (again, evidence of wind uplift action prior to the failure of the roof system; see Fig. 3–38). There were a few girders that were disconnected from the columns on one end. These appeared to have been secondary failures (after loss of the roof system and therefore any lateral bracing for the girders).

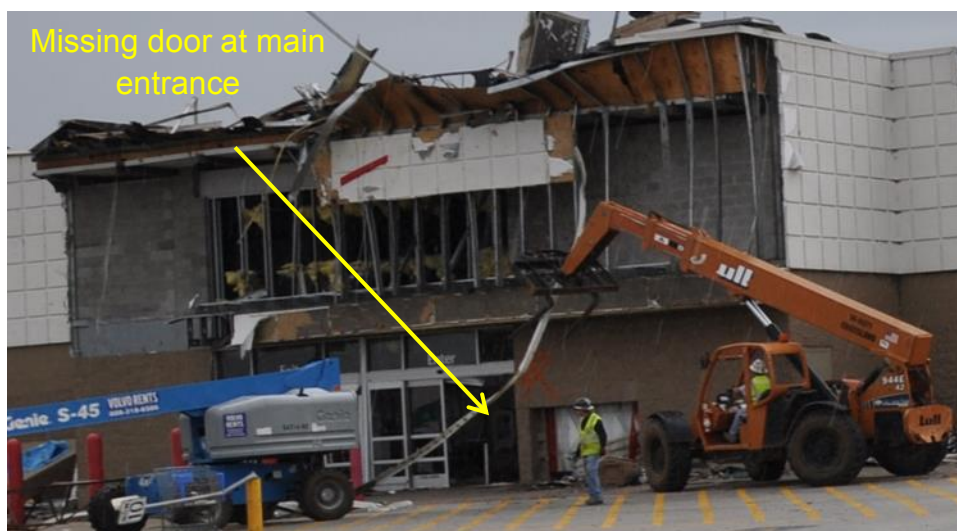
- Envelope:
 - The entryway door panels (tempered glass and aluminum frame) on the west wall were lost and there was damage to the fire-escape door on the east wall and to the store's exterior signage. These impacts were likely due primarily to wind pressure. Whole door panels, including the glass and aluminum frame, were missing. (The glass on door panels that remained appeared intact (see Fig. 3–39). This allowed wind to infiltrate the building interior and resulted in increased wind uplift pressure on the roof system.

Figure 3–39. Missing door and glass panels and damage to signage at south entrance on west wall (envelope failure allowing air infiltration to the interior and causing increased wind uplift).

1. Wind pressure built up and caused the failure of components of the building envelope and wind infiltration into the building interior (through the entryway door and window panels in the front (west) wall, the fire-escape door in the back (east) wall, and exterior signage; see Fig. 3-39).

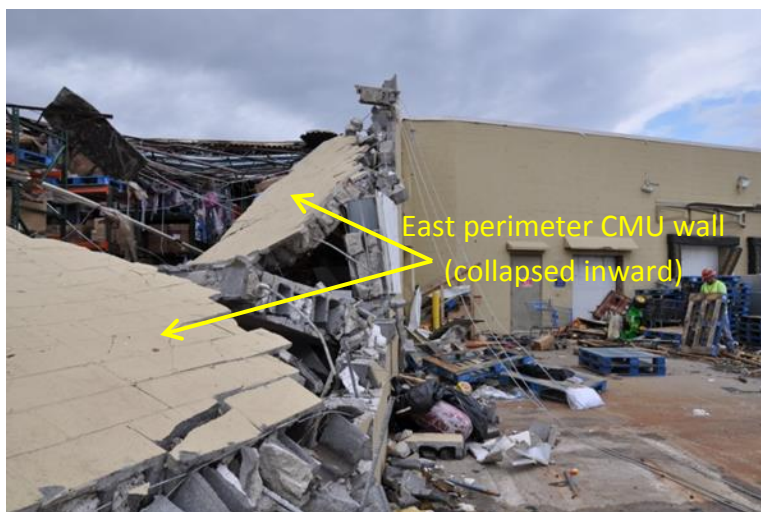
Figure 3–40. Collapsed east wall due to loss of roof lateral bracing and inward wind pressure.

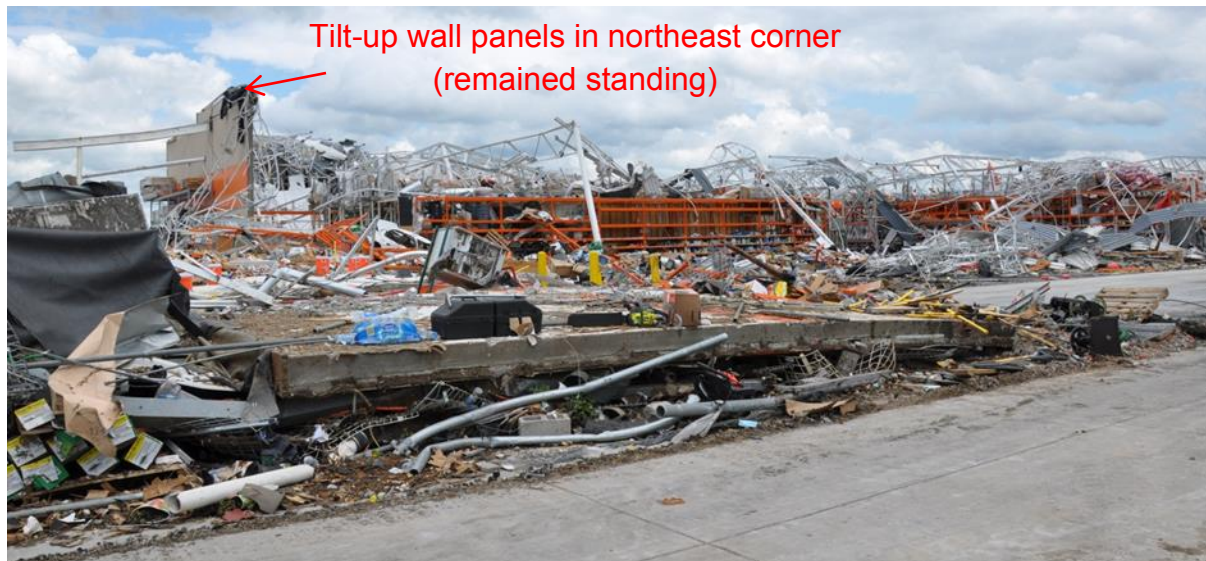
- The loss of the entire roof system and collapse of the wall panels represented a failure of the building envelope. It is not known if the doors on the north, east, or west walls were breached prior to the collapse of the entire building. However, the metal roll-up doors at the loading dock on the north wall (uncollapsed wall panels) appeared to have remained closed during and after the tornado.

Figure 3–49. Collapsed Home Depot building (view from the northwest). Note the loss of all roof decks and upward displacement of joists and joist-girders

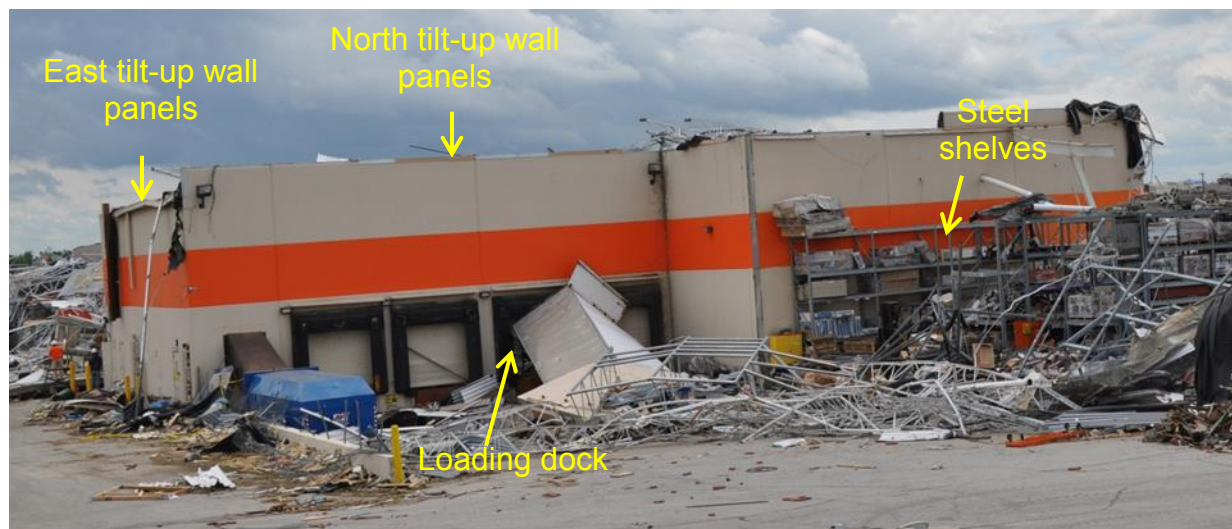
Figure 3–50. Ten tilt-up panels in the northeast corner remained standing. Seven of these 10 panels had positive connections to the footing and thus some degree of restraint against rotation. The other three uncollapsed panels had friction-only connections to the footing but appeared to have been supported against falling outward by steel shelving on the exterior side (Garden Center).

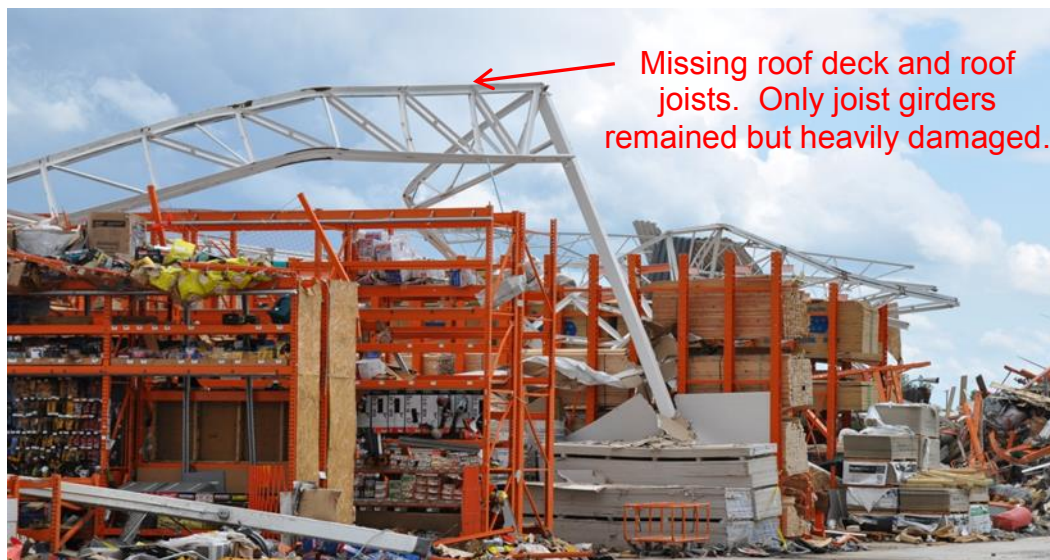
Figure 3–51. Damaged joist girders and interior columns. Note the complete loss of the roof system that was connected to the girders.

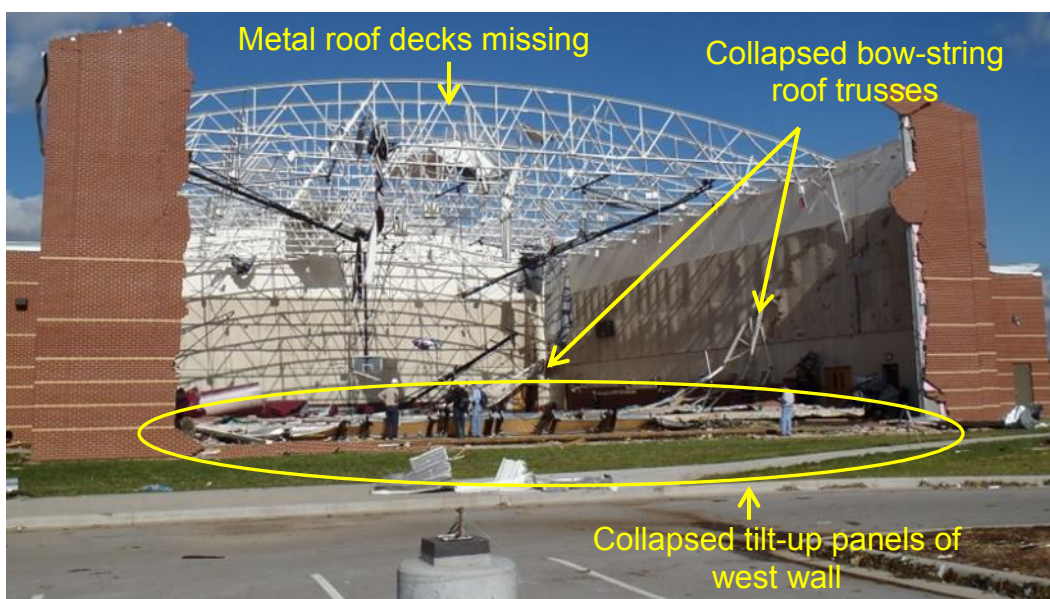
1. The loss of all roof covering materials and most of the metal roof decks (see Fig. 3–56 and 3–57). The disconnection of the roof decks from the supporting bow-string roof trusses appeared to be due to failure of the puddle welds (whole panels, each three-span or 30 ft

Figure 3-56. Joplin East Middle School Gymnasium building, viewed from the west, showing complete loss of steel roof deck, disconnection and collapse of the first two bow-string steel trusses, and collapse of 9 out of 11 tilt-up panels of the west wall.

3. The collapse of 9 out of 11 tilt-up wall panels of the west wall toward the building's interior (along the tornado's translational direction). These collapsed panels became truly unbraced laterally after the disconnection and loss of the roof decks. The two panels of this wall that did not collapse were end panels that were also laterally supported along their height by bearing against the end panels of the north and south walls. Thus, these two panels did have some lateral support aside from the lateral bracing provided by the roof system, unlike the nine intermediate panels that collapsed.

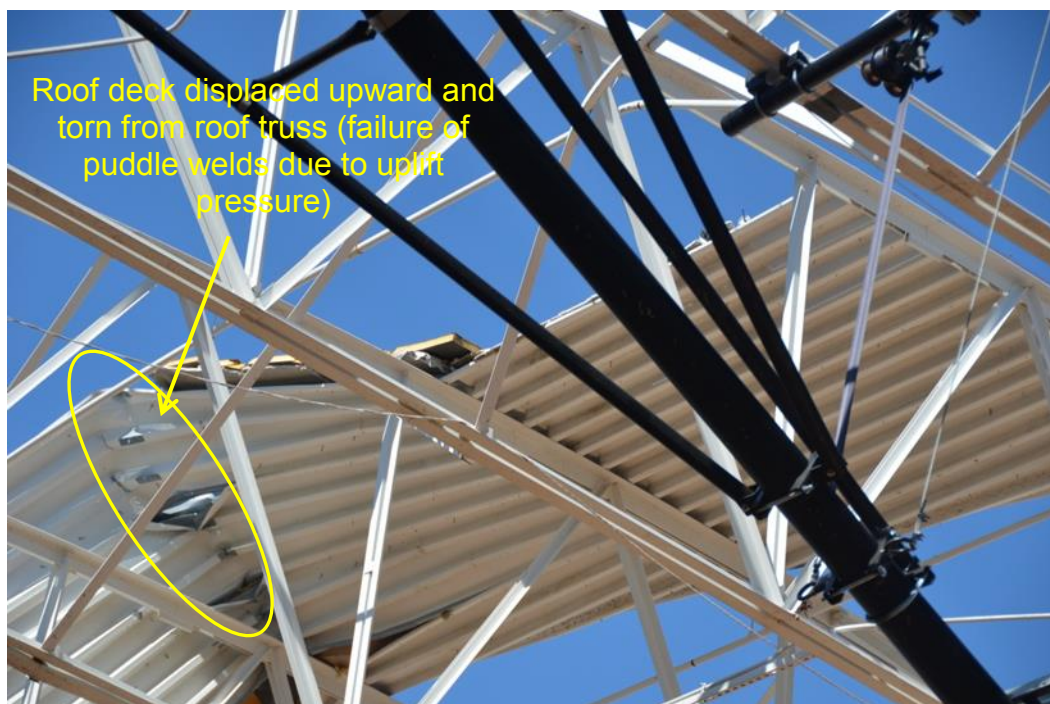
Figure 3–57. Disconnection of steel roof deck of Gymnasium due to failure of puddle welds due to uplift pressure.

- long, were disconnected at puddle-weld locations). A few perimeter wall panels fell into the interior of the building, while most were blown away from the building. The loss of the roof decks effectively removed the interior lateral bracing for the tilt-up wall panels of the north, south, and east walls (these walls, however, were still braced on the exterior by the roof systems of the surrounding building sections as described above) and the sole lateral bracing system for the tilt-up panels of the west wall.

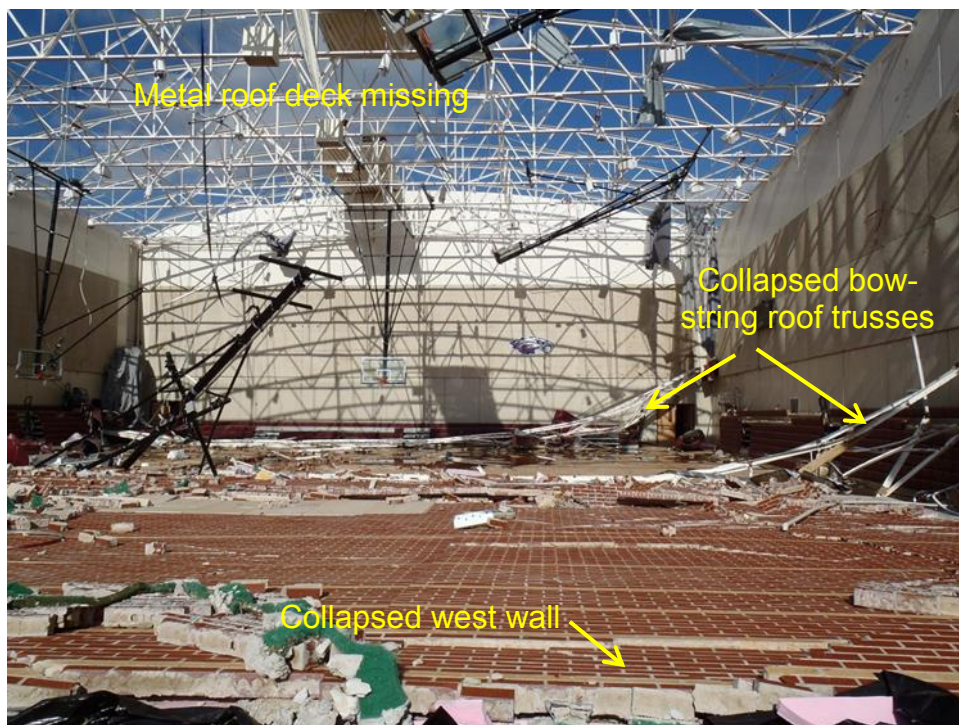
2. The disconnection and collapse of the first two bow-string roof trusses (nearest to the west wall). Both of the collapsed trusses sustained lateral, out-of-plane bending, and their disconnections from the top of the tilt-up wall panels appeared to have resulted from shear failure at the embedded seat angles at the ends of each truss (either shear fracture of the welds between the vertical headed studs that were embedded in the concrete or of the welds connecting the joist to the seat angle; see Fig. 3–58 and 3–59).

Figure 3-58. Collapsed bow-string roof trusses and collapsed west wall tilt-up panels in the interior of the Gymnasium.

The failure of the roof deck-to-joist connection and subsequent loss of all the roof decks resulted in nine tilt-up panels of the west wall becoming laterally unsupported and simply overturning at the base in the direction of lateral wind load (west to east). As these panels fell toward the interior of the building, they impacted the first two bow-string roof trusses that were nearest to them (and within their collapse radius), resulting in out-of-plane bending of the trusses, subsequent shear failure of the truss-to-wall connections, and ultimately the collapse of these two roof trusses (see Fig. 3-58, 3-59, and 3-60).

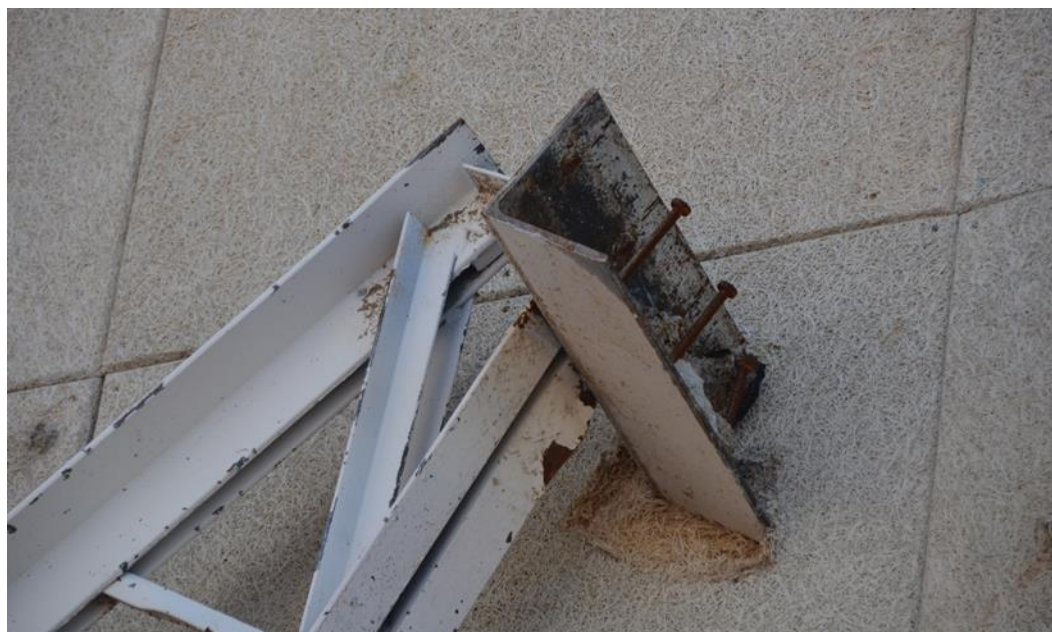
Figure 3-59. Seat angle welded to end of bow-string roof truss and embedded into top of tilt-up panel got disconnected. Note missing vertical headed studs (4, each 10 in. long), which appeared to have been sheared off from the angle. The three horizontal studs remained connected to the seat angle but pulled out from the concrete.

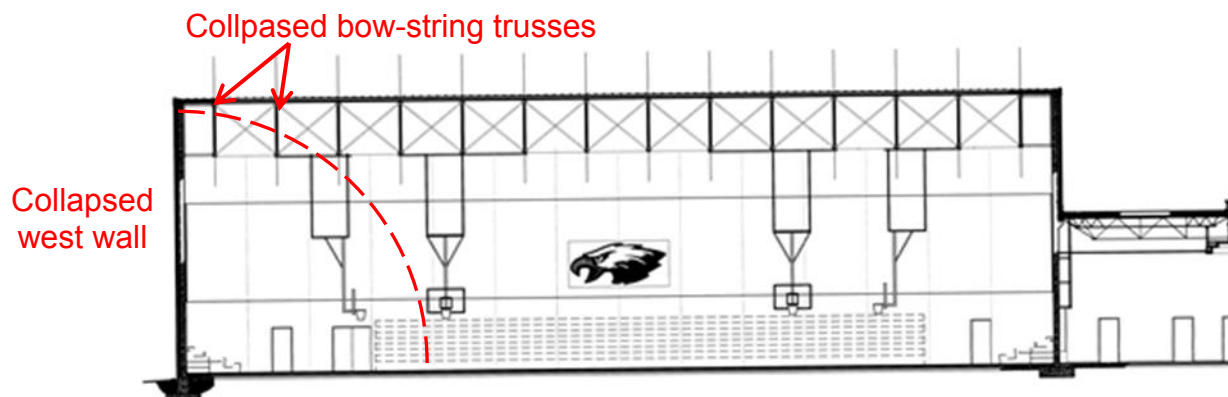
Figure 3-60. Elevation showing first two bow-string roof trusses and collapse radius of west wall.

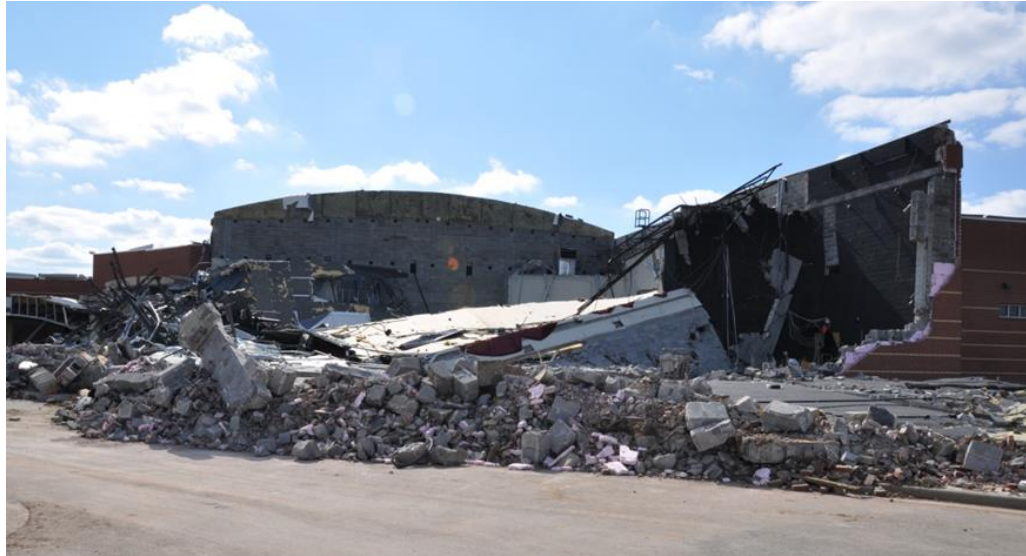
1. The disconnection and loss of roof decks in part of the roof, and the collapse of the entire roof system (trusses, steel deck, and roof covering) into the building interior (see Fig. 3–61 and 3–62).
2. Collapses of the east and south perimeter CMU walls, with the south wall collapsed into the building (toward the north) and the east wall collapsed outward, away from the building (toward the east). Similar to the collapsed CMU walls of other BTS buildings in the May 22, 2011, Joplin tornado, the east and south walls failed due to overturning of the entire wall at the wall-to-foundation connections, rather than due to inadequate strength within the CMU walls (see Fig. 3–63).

Figure 3–61.
View from
east of
Auditorium
building.

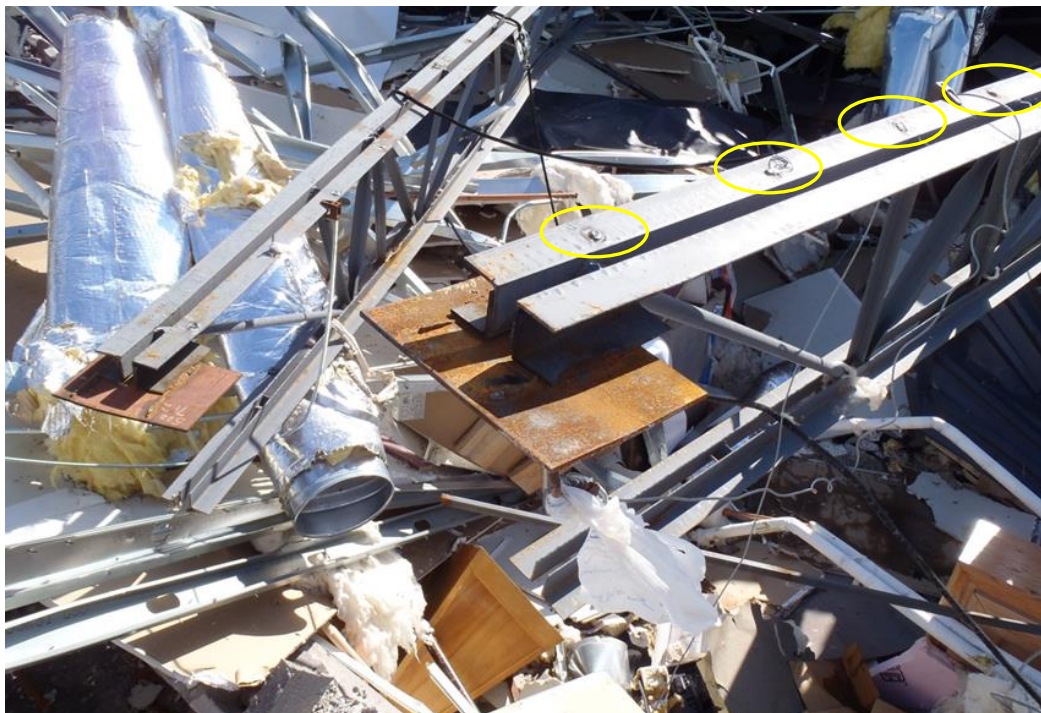
Figure 3–62. In wreckage of Auditorium, missing roof deck from top of joist—only puddle-weld marks remained.

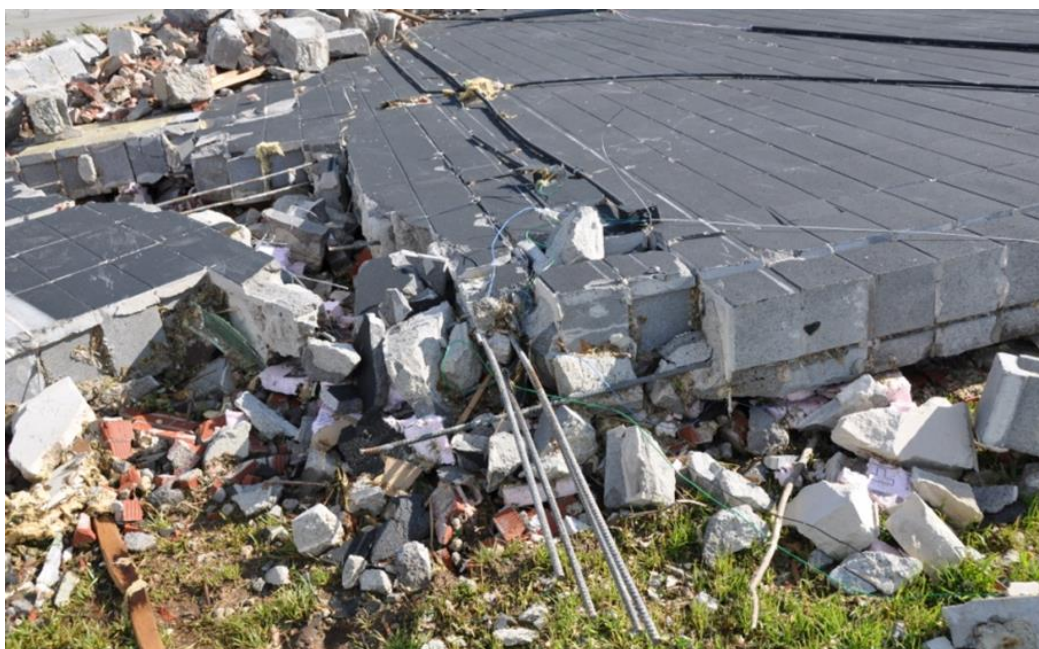
Figure 3–63. Collapse due to overturning (outward) of east perimeter Joplin East Middle School Auditorium wall after loss of roof diaphragm.

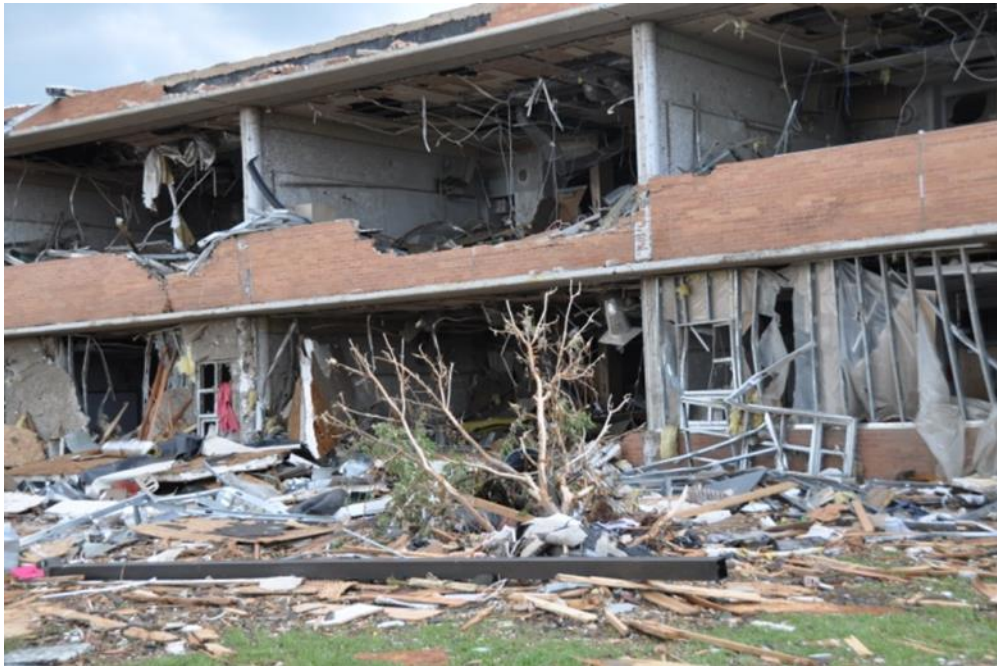
Figure 3–66. View from the exterior showing damage to the envelope of one of the RC frame buildings (east building) of Joplin High School.

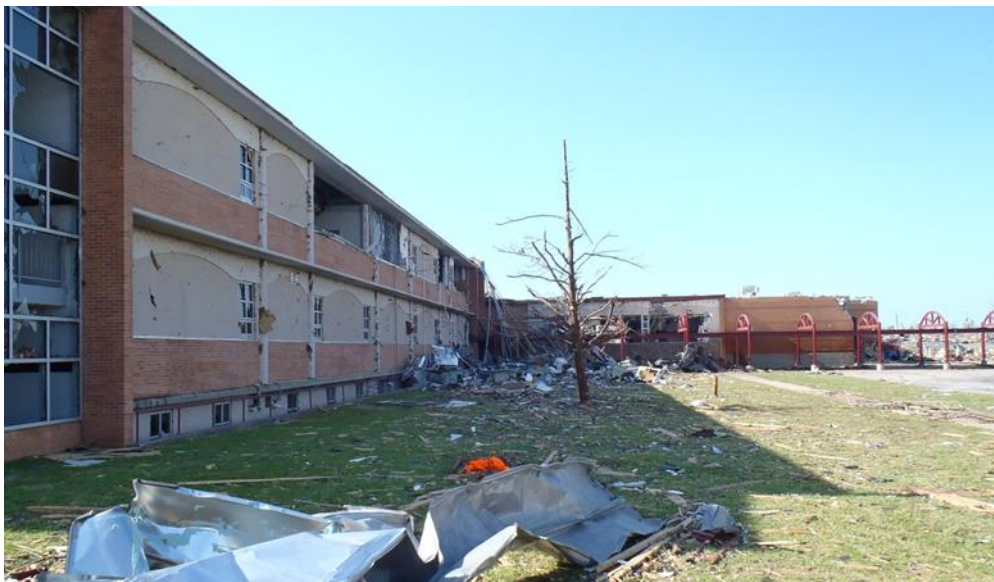
Figure 3–67. View from the exterior showing damage to the envelope of one of the RC frame buildings (west building) of Joplin High School.

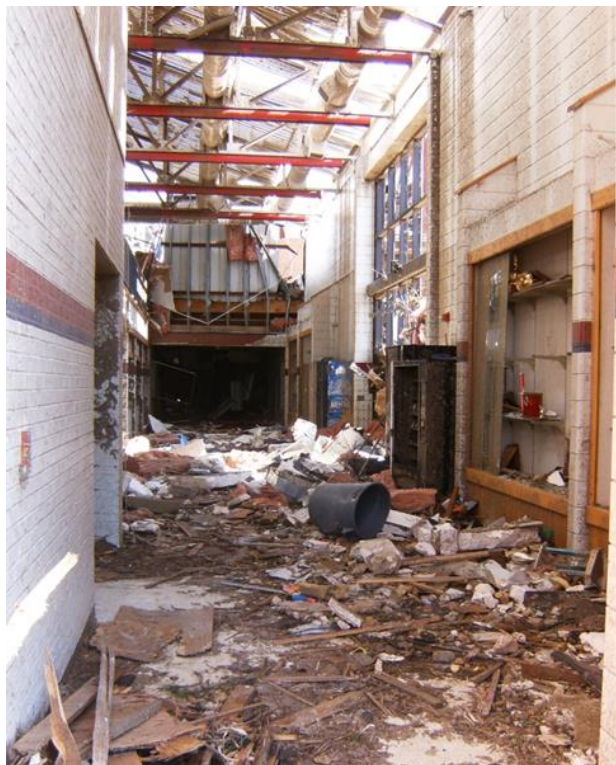
Figure 3–68. Damage and debris in an interior hallway of Joplin High School.

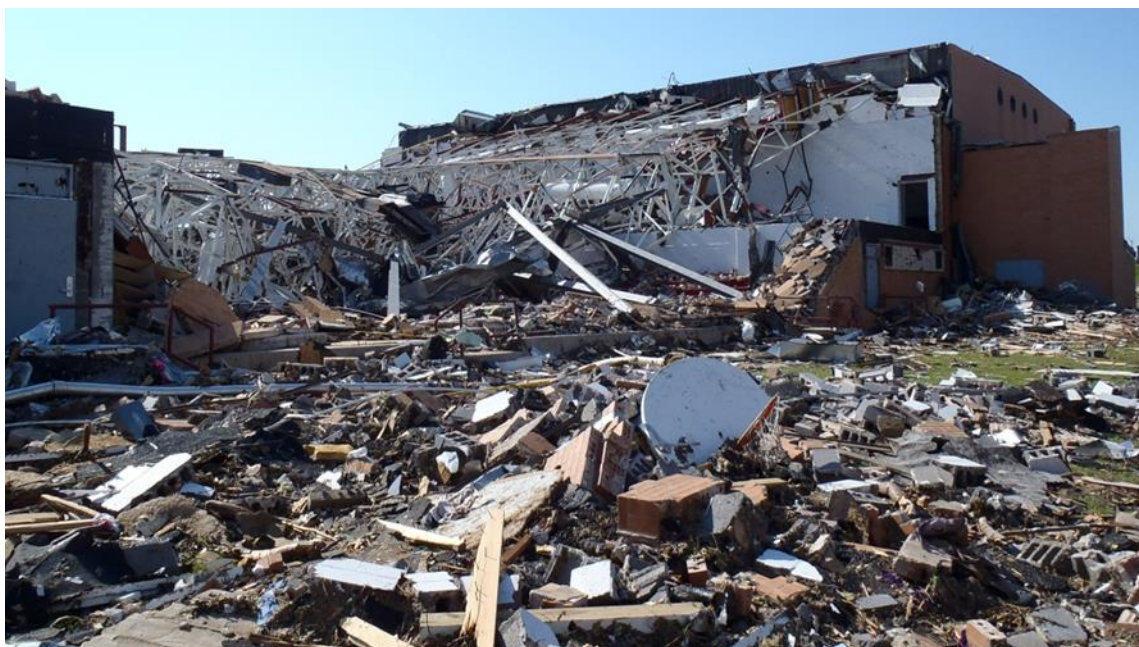
The building sustained a total collapse of both the structural frame and the envelope, including: (a) the disconnection and loss of all steel roof decks; (b) failures of the column-to-floor bolted connections and of the embedded connections between the roof girders and the tops of the CMU walls, which resulted in the collapse of several individual steel columns and of the entire roof system; and (c) the collapse of large portions of the east and west exterior walls due to loss of lateral bracing from the roof system. Fig. 3–69 shows a view of the collapsed Gymnasium building.

Figure 3–69. View from west of the Joplin High School Gymnasium building.

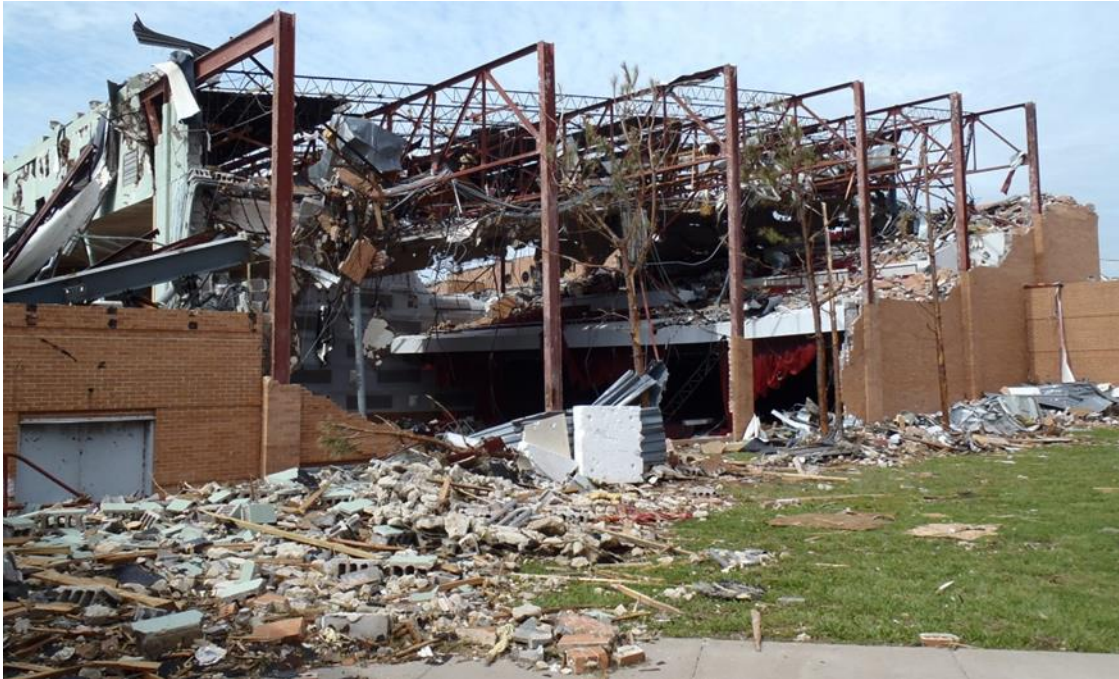
The structural steel frames of the Auditorium building appeared to have sustained only minor damage, with all six frames remaining intact despite the failure of a few lateral braces between them. However, the damage to the roof (lateral bracing) system was significant, with (a) disconnection and complete loss of most of the steel roof deck panels; (b) loss of a large number of the open-web steel roof joists in several spans; and (c) the collapse of most of the exterior URM/brick walls. Fig. 3–70 shows the north side of the Auditorium building.

Figure 3–70. View from north of the Joplin High School Auditorium building.

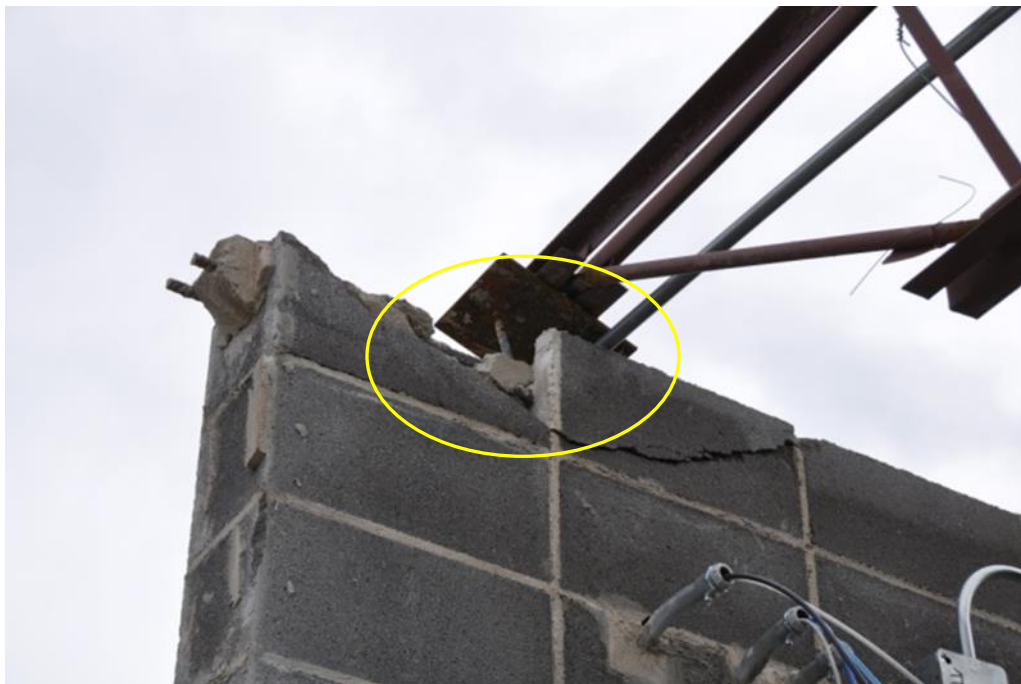
These single-story BTS buildings typically had CMU walls made of three layers (a partially grouted and reinforced concrete masonry inner layer, a foam insulation middle layer, and an outer brick layer). The top course of the CMU at the top of the wall was grouted to form a continuous cap beam for anchorage of the steel roof joists. The bottom of the CMU wall was anchored (only about 6 in. deep) into the concrete footing with steel reinforcing bars. The typical damage to these buildings included disconnection and loss of panels of the steel roof deck and failure of the connection between the steel roof joists and the CMU

Figure 3–71. Failure of joist-to-CMU wall connection due to uplift.

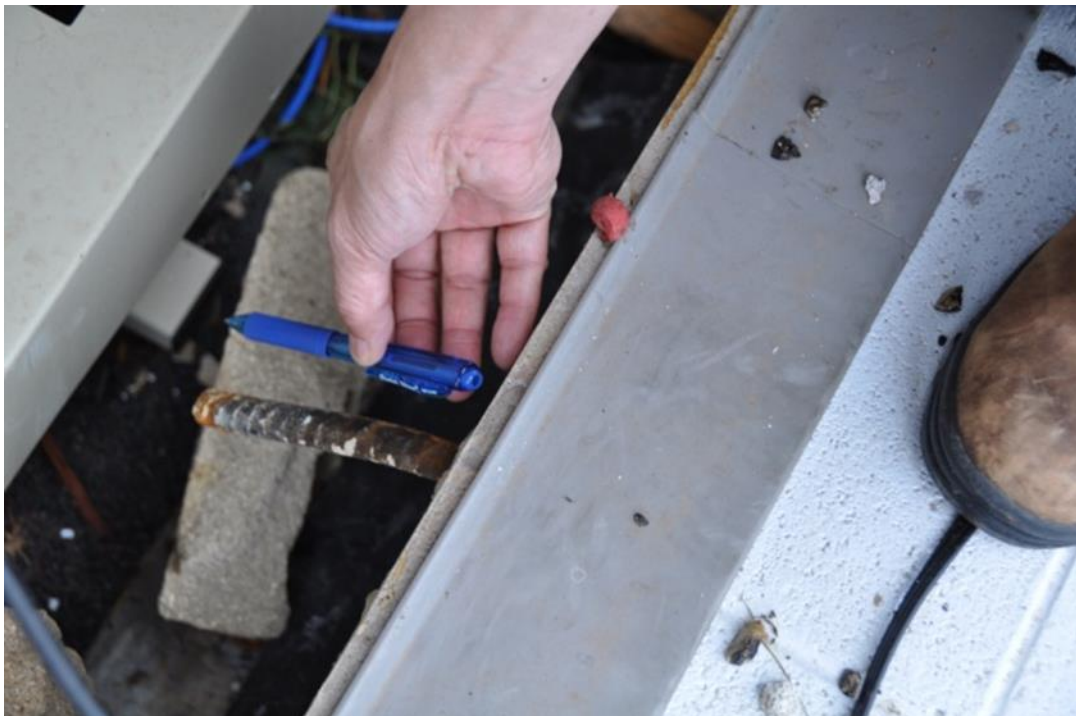
Figure 3-73. Short anchorage between CMU wall and concrete footing.
